US Army Corps  
of Engineers  
Construction Engineering  
Research Laboratories

Technical Report REMR-OM-19  
June 1997

# REMR Management Systems—Navigation and Flood Control Structures, Condition Rating Procedures for Lock and Dam Operating Equipment

by *James H. Stecker, Lowell F. Greimann, Scott Mellema, and Kevin Rens*  
*Department of Civil and Construction Engineering*  
*Iowa State University*

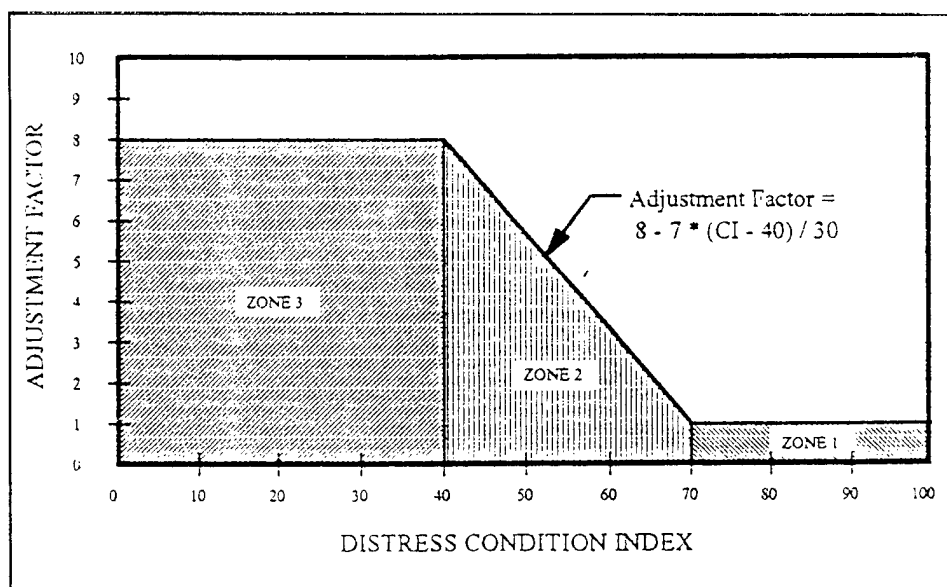
Figure 3 shows the value of the adjustment factor versus the  $CI_i$ .

Figure 3. Weight adjustment factor for condition index.

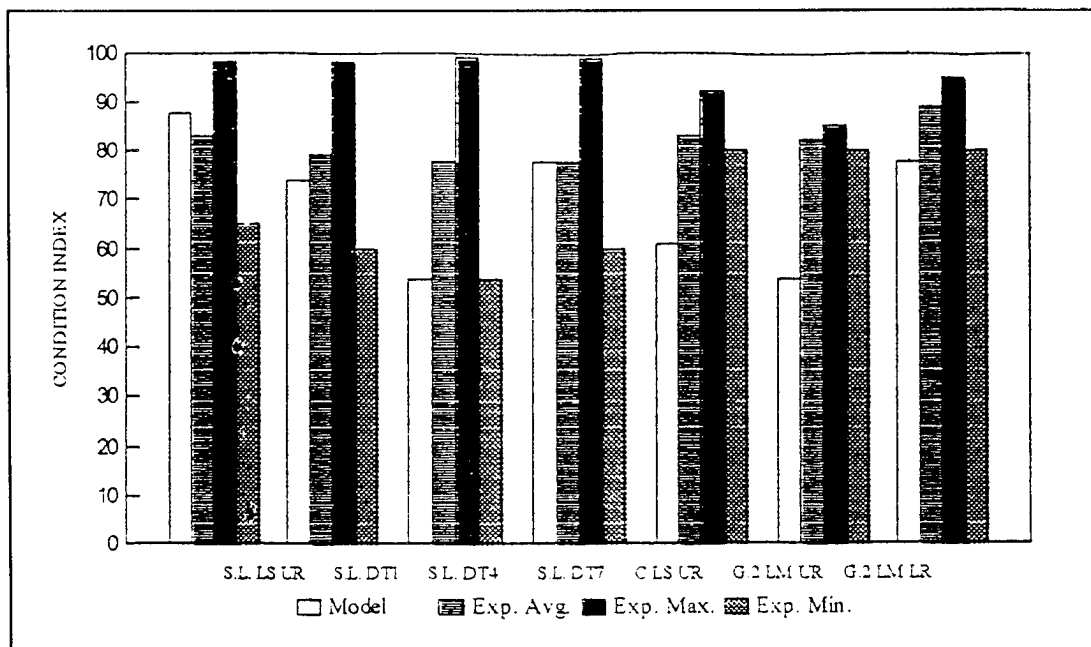
Figure 14. Reduced tooth contact: exposed gear assembly.

### **Reduced Tooth Contact: Figure 14**

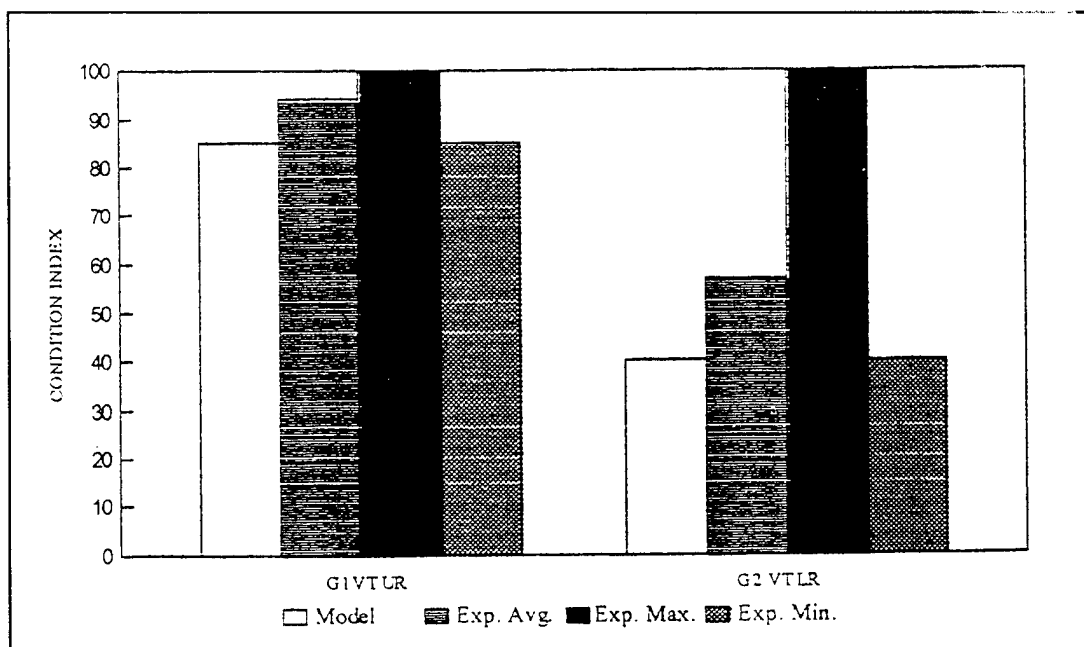
Figure 17. Anchorage movement/deterioration: enclosed gear assembly.

### **Anchorage Movement/Deterioration: Figure 17**

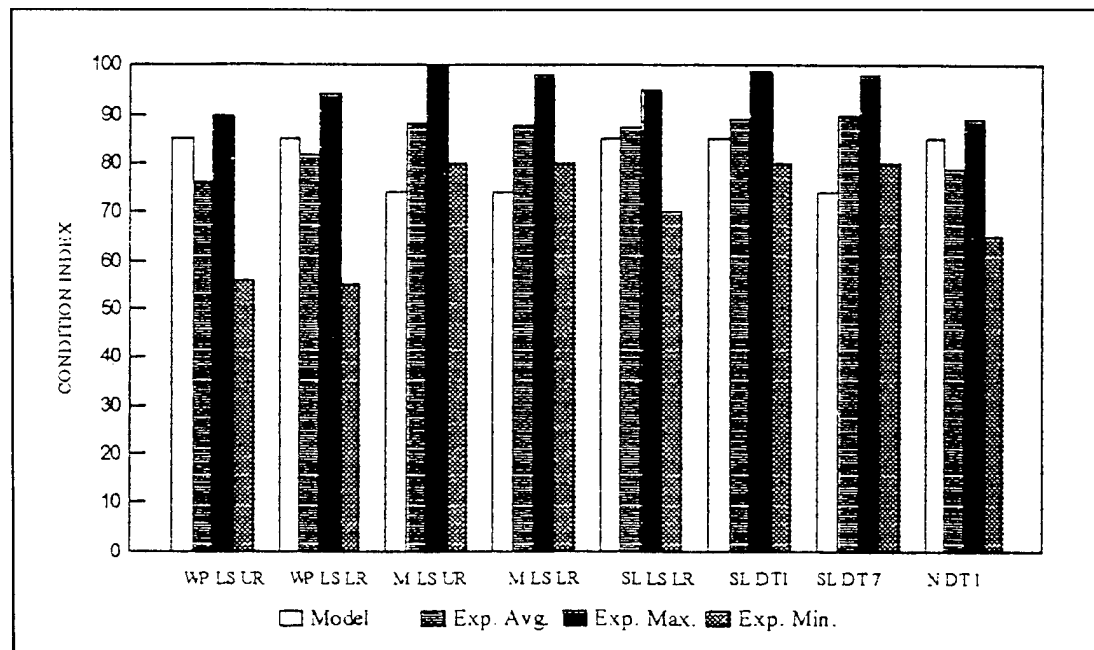
Figure 21. Oil contamination: enclosed gear assembly.

### Oil Contamination: Figure 21

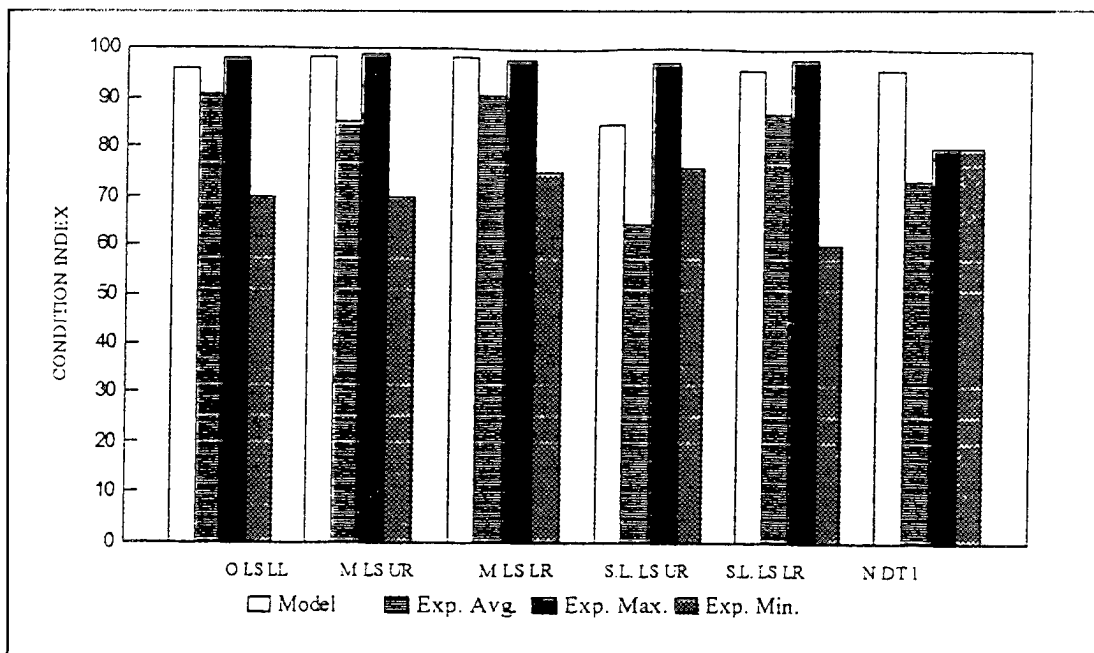
The assembly CI for strut arms was calibrated for six assemblies. In each case, the model CI was higher than the experts' average CI. Although the model CIs were higher, the experts' average CIs and the model CIs were all in Zone 1.

Figure 30. Strut arm assembly CI.

### **Assembly CI: Figure 30**

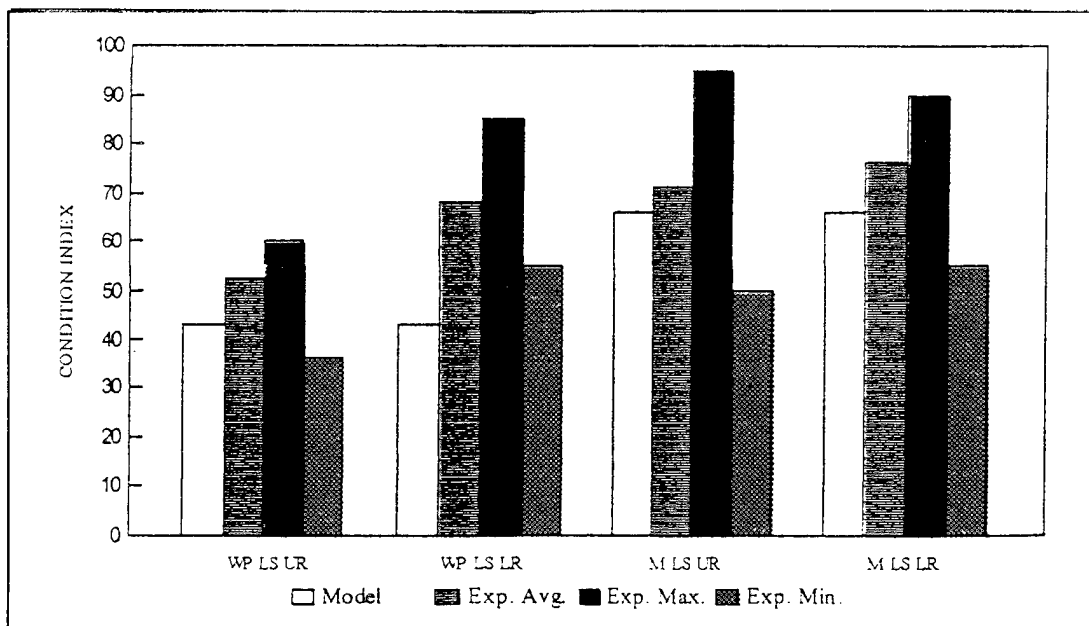
Figure 44. Outer wire wear: cable assembly.

The bar charts in Figures 44 and 45 compare the experts' subjective CI from the various field tests to the CI calculated from the rules in Section 9.3 for two cable distresses. Only data from assemblies with observed distresses were plotted. Comparisons between the calculated and experts' average CIs are summarized below.

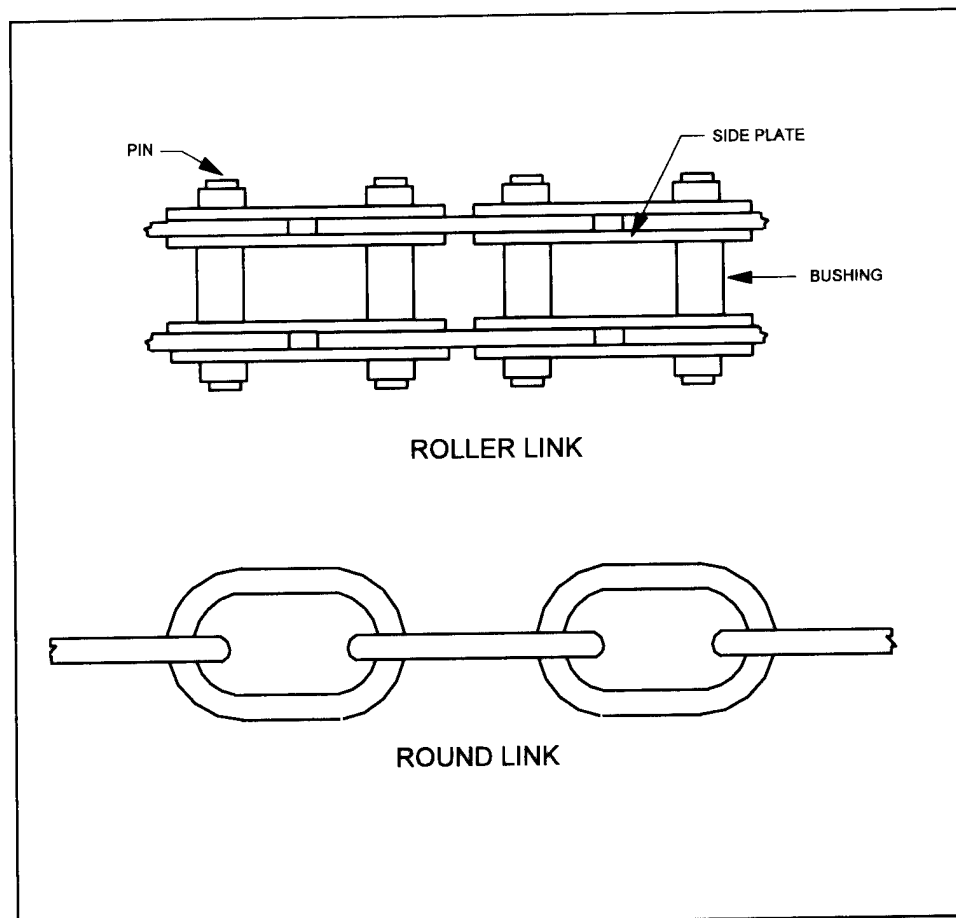
Figure 48. Chain link schematic.

The sprocket is the component that retrieves the chain as it rotates. The chain links fit on the sprocket teeth.

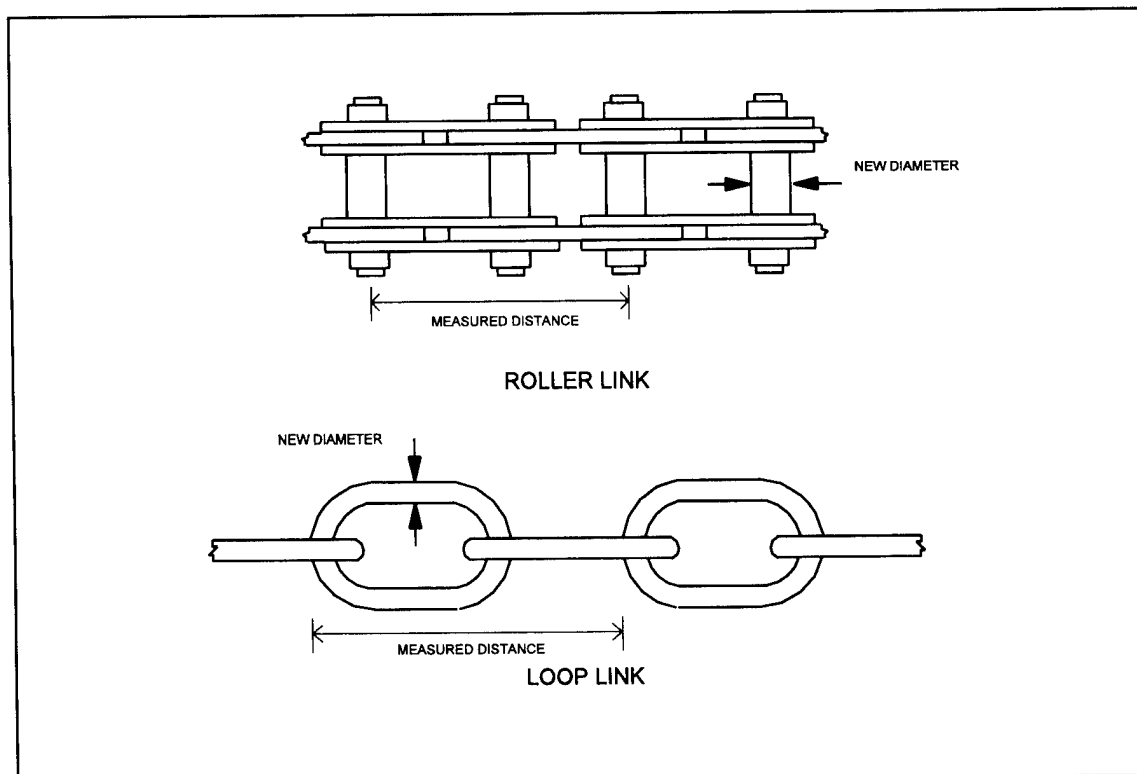
Figure 49. Chain linkage wear.

LINKAGE WEAR/ELONGATION of the chain occurs between the links of the chain (Figure 49). Record the LENGTH OF WORN/ELONGATED LINKS. This distance can be measured on a roller link chain by placing a tape measure along the loaded chain and measuring from the center to center of several consecutive link pins (Figure 49). For a round link, measure from end to end of the links while the chain is loaded (Figure 49). To get a more accurate estimate of total wear and elongation, measure 10 to 20 consecutive links and divide the measured distance by the number of links. The worst worn or elongated links will most likely be those that ride on the sprocket most frequently, if the gate operates at a relatively constant elevation. Also record the LENGTH OF NEW LINKS. This distance can be obtained from construction drawings. If construction drawings are not available, measure the distance between links that get little use, and use this distance as an estimate of the distance between new links.

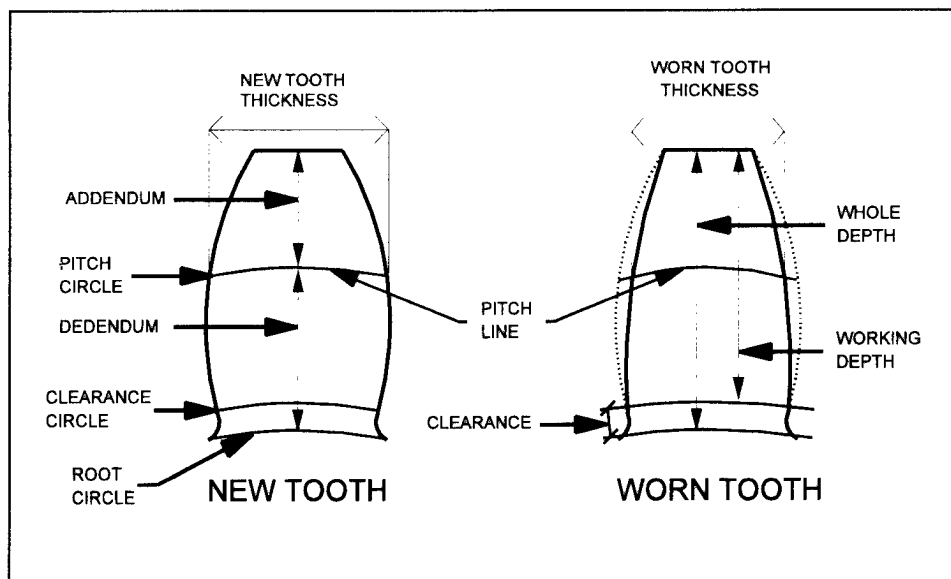
Figure B1. Gear tooth dimensions and wear measurement.

To inspect and rate gear and rack tooth wear, familiarity with the nomenclature used in describing gear and rack teeth is necessary; definitions for the various tooth relationships are presented in the following paragraphs and shown in Figure B1.
